Service News

BULLETIN NO. **E-1153** 1/2

RX-V661/RX-V861
HTR-6060/HTR-6080
DSP-AX761/DSP-AX861SE

Diode Replacement

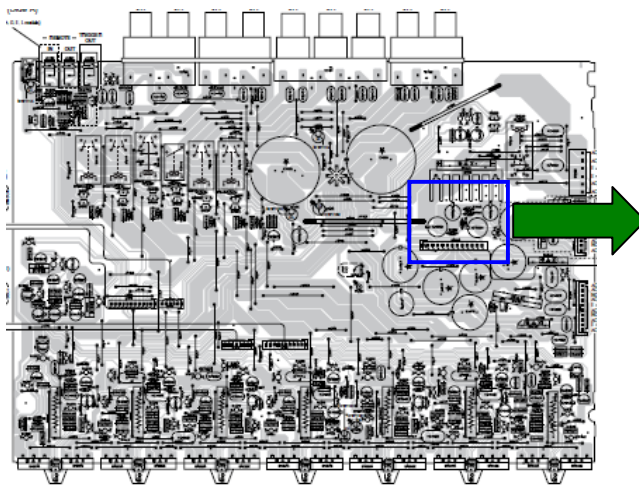
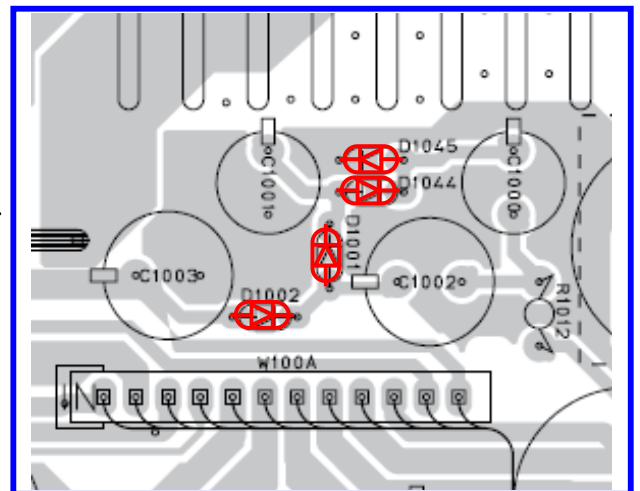
RX-V661/HTR-6060/DSP-AX761 Main P.C.B. (1)

PURPOSE: If “NO POWER” symptom is due to shorted diode and puffed up capacitor in the Main(1)[RX-V661/HTR-6060/DSP-AX761] / Function(2) P.C.B.[RX-V861/HTR-6080/DSP-AX861SE], even if 1 or 2 diodes are shorted, replace all 4 diodes with heavier duty diodes as described below. Capacitors should be replaced with the same/original types.

Previous Parts

Ref. No.	Parts No.	Description
D1001, D1002, D1044, D1045	VN008700	DIODE 1SS270A

New Parts

Ref. No.	Parts No.	Description
D1001, D1002, D1044, D1045	VV307700	DIODE 1N4002S
