Model: **CR20**
CD changer mechanism

- Subject:** : Disc spacer is come off
Objective Model : CR20 (CD changer mechanism)
Symptom: : Disc spacer which is come off effect other mechanical operation.
 Therefore some symptom appear.
 * CD Changer operation does not work.
 * CD does not play.
 * CD tray does not open. and so on.

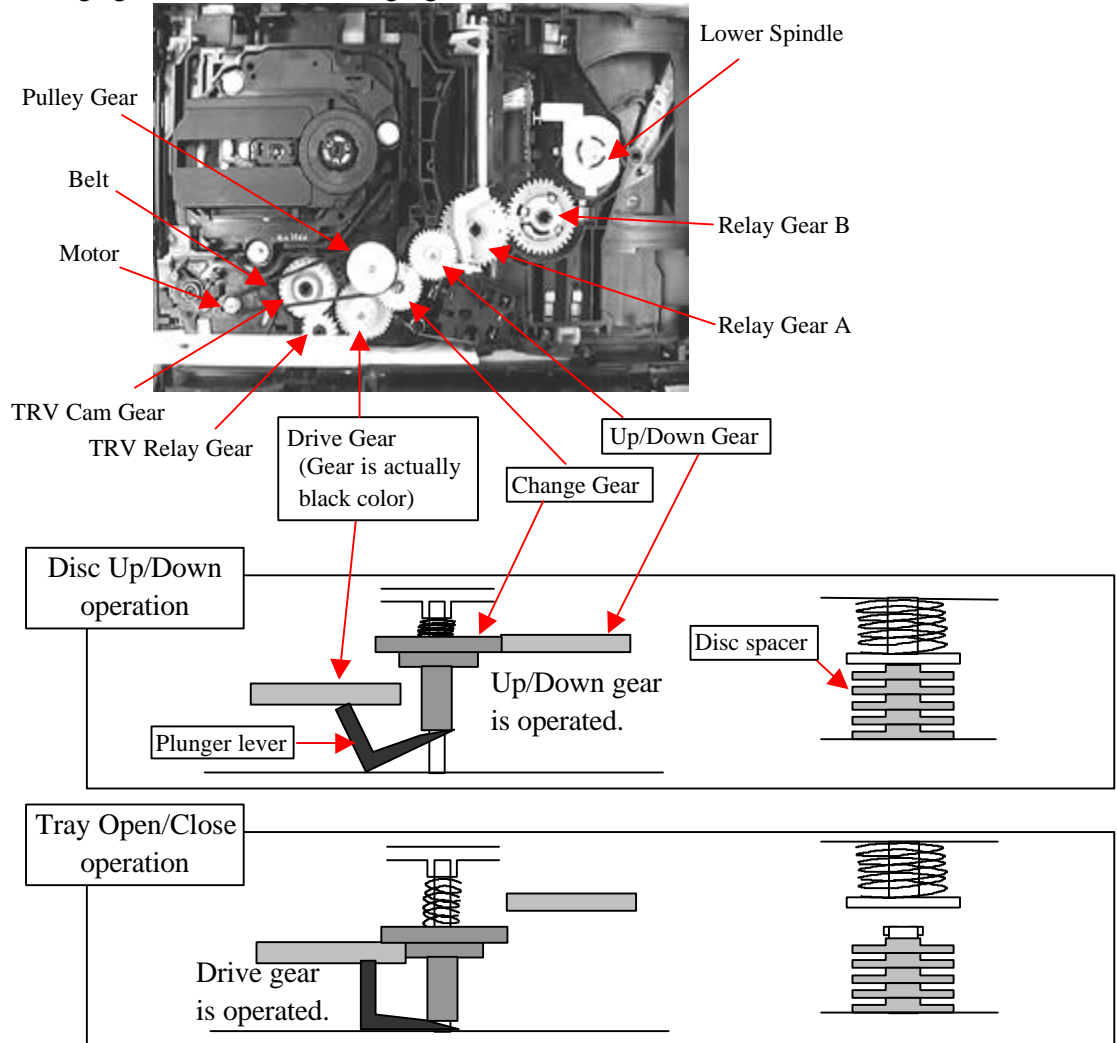
Cause: : This mechanism control the switching of Disc Up/Down and Tray Open/Close operation by Change gear. (Refer to following figures)

Remedy: Replace the Change gear spring to strong one due the Change gear drop down surely.

Original	New
RMB0549	RMB0549-1

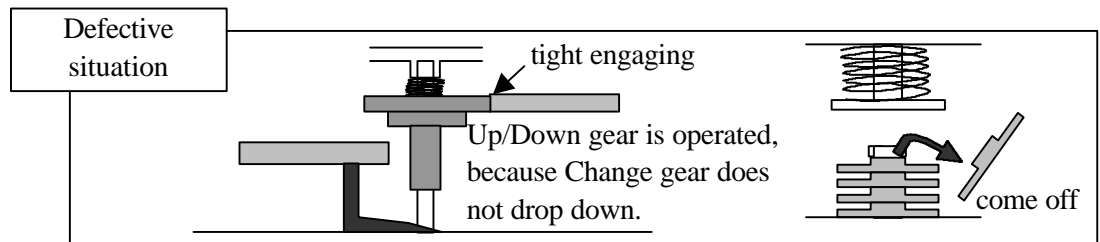
If the Change gear does not drop down due to tight engaging between Change gear and Drive gear when switching to tray open/close operation, Disc spacer come off.
